NEPRA Alert # 2021-02/ December 18, 2021

Distribution Transformer Explosion

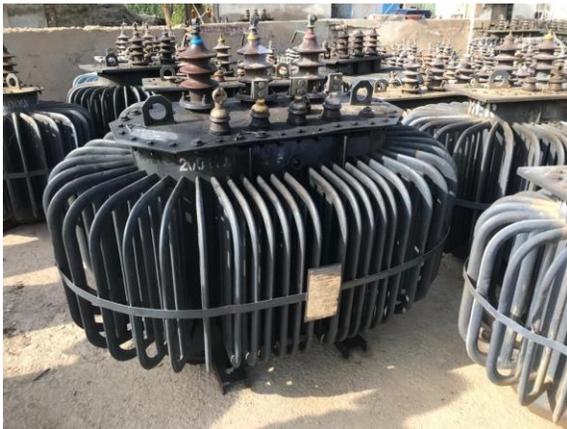
Figure-1: 200kVA Transformer

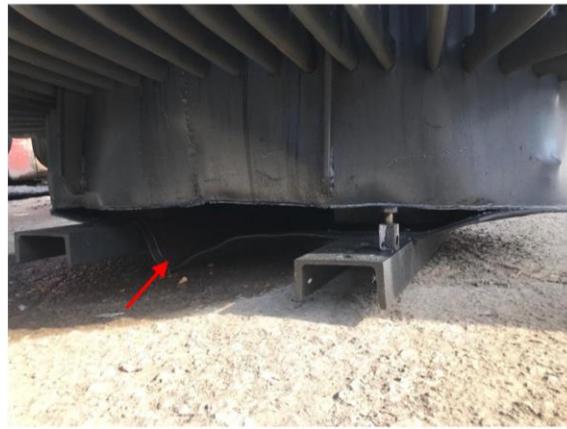
Figure-2: Transformer Bottom Plate Rupture

6. The weakest point of the transformer tank was the weld joint in the bottom base plate, a 4mm thick plate that ruptured after explosion. It was found that the welding beads on the bottom base plate of

this transformer tank had an uneven poor bead profile. Since there is no requirement for welding in the specification, welding was done only from the outside, not from the inside.

7. Replace all substandard rora fuses installed on the transformers under operation with fuses of standard size and rating.
8. The welding requirements and strengthening of the base plate of a transformer should be considered in the specification including internal and external welding techniques, welder certification, welding inspection, and quality control.

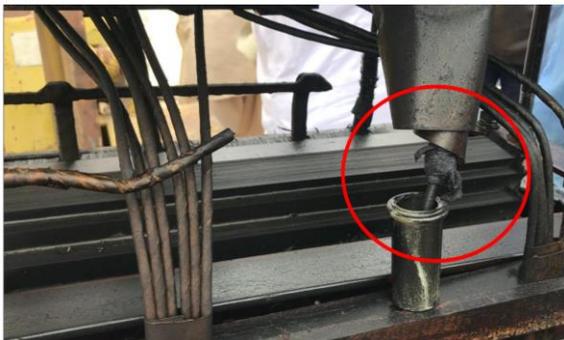
Figure-3: HT Side Terminal Connection

2. The distribution transformer was repaired in a private workshop, where a broken HT terminal was attached manually without soldering, and the connection was wrapped up with a substandard cotton tap and loose insulating paper. The transformer was installed without being tested or certified as fit for use. Also, loose connections in the transformer can cause a spark and overheating. Insulation oil was also contaminated by moisture through substandard repairs.

2. The number of authorized workshops should be increased and should have all of the repair facilities required by NTDC specification # DDS-84-2020, including testing facilities for transformer reliability and integrity.

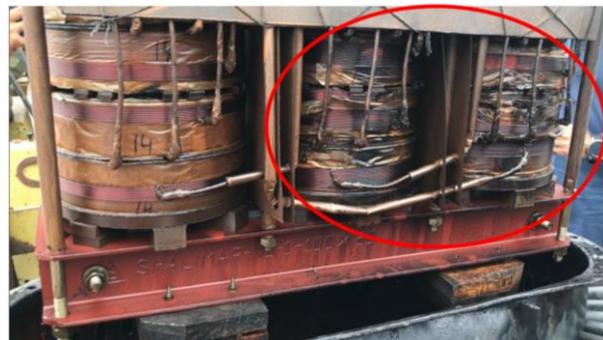
Figure-4: HT Side Short-circuited Windings

3. In peak summer during the Eid holidays, the transformer was loaded above 100%. Two of the three HT side windings were short-circuited when energized due to the overloading of the transformer. The transformer oil was already contaminated and the percentage of moisture had been increased from a private workshop, thus affecting its dielectric properties, causing oil temperature to rise, evaporation, and the formation of combustible gasses which expanded violently, causing the transformer tank to bulge rapidly and catch fire within 12 seconds, resulting in a heavy explosion of the transformer. As a result of oil dripping from the transformer, it was observed that the insulating oil in the tank might not be sufficient.

6. A comprehensive study should be carried out periodically to assess the loading position of all distribution transformers and to take subsequent measures, such as augmentation of transformers to prevent overloading and breakdowns.

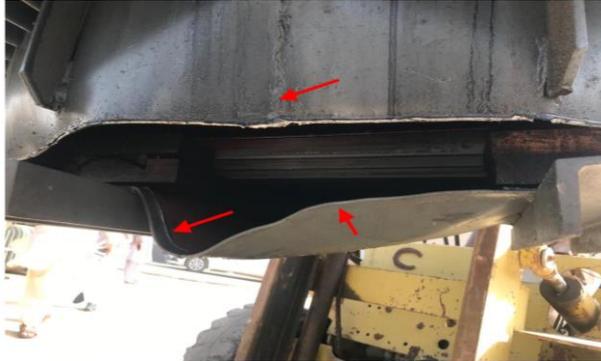
Figure-5: Tank Sheet and Bottom Plate

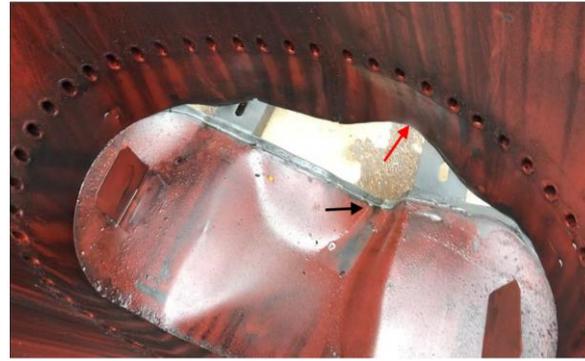
Figure-6: Transformer Tank Internal View
