NEPRA Incident Alert # 2022-01/ Sep 15, 2022

Coal Dust Explosion

Summary

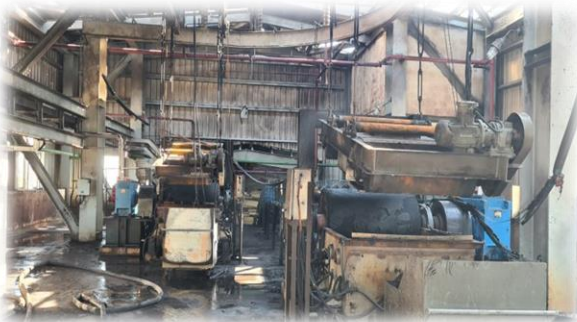
Figure-1: Coal Handling Area after Explosion

On March 2, 2022, at 16:47 hrs., a coal dust explosion caused a fire in the coal conveyor system of a coal-fired power plant while start-up activity was in progress after a scheduled outage. Prior to the explosion, one of the vibrating screen start attempts failed. Electricians checked the local panel under live electric work permit and found that the local panel breakers were in the “ON” position. Despite this, none of the vibration screen motors were running. Upon inspection, the electrician found no specific fault in the control panel and only re-set it to auto mode. The DCS operator initiated the auto start-up sequence for the vibration screen's motors. An explosion caused a fire just above the vibration screen box when the last motor was started. The most likely source of ignition was metal-to-metal mechanical friction between vibrating sieve with the body of vibrating screen at the time of motor start-up, which produced sufficient heat and sparks to ignite coal dust and caused an explosion.

Automatic sprinklers were activated in the area, conveyor belts were automatically shut off, and the DCS operator activated emergency shutdown of the entire coal handling system. As a result of the explosion and fire, the coal conveying system, electrical cabling as well as instrumentation accessories were damaged. Immediately, emergency services were dispatched to the scene to control the fire. Fire trucks and water bowsers arrived from nearby companies. As the smouldering coal became approachable and accessible, ERT team members entered the building and completely extinguished the smouldering coal with fire extinguishers.

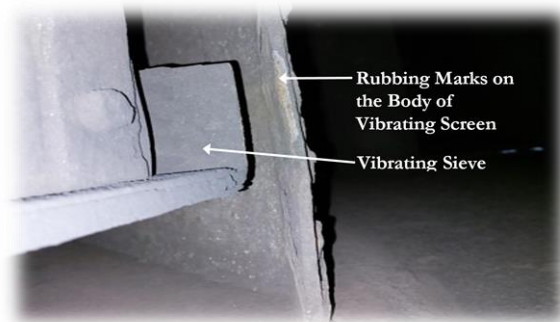
Figure-2: Vibrating Screen

8. At the time of motors start-up, the vibrating sieve stroked/rubbed against the vibrating screen body, produced sufficient heat and sparks to ignite accumulated coal dust and caused an explosion.

9. When the equipment was re-opened for inspection following the incident, rubbing marks were noticed, caused by mechanical movements between the mating parts.

4. Revise the inspection program for the equipment's to address abnormal vibrations, misalignments, loose objects, potential rubbing parts, and normal wear & tear in order to prevent mechanical friction, overheating, and mechanical sparks that may cause fire.

5. The box-up certificate should include inspection pictures of the equipment before boxing up for record and history purposes.
6. Maintain the integrity and reliability of overload protection devices on drive motors in the PM program, as overloading will raise the operating temperature above "normal".
