# **National Electric Power Regulatory Authority**

**SUBJECT: ORDER OF THE AUTHORITY IN THE MATTER OF SHOW CAUSE NOTICE ISSUED TO LESCO UNDER SECTION 27B OF THE NEPRA ACT READ WITH OTHER RELEVANT RULES & REGULATIONS OF THE NEPRA ACT REGARDING FATAL ACCIDENTS OCCURRED IN LESCO DURING THE FISCAL YEAR 2023-2024**

### IN THE MATTER OF SHOW CAUSE NOTICE ISSUED TO LESCO UNDER SECTION 27B OF THE NEPRA ACT READ WITH OTHER RELEVANT RULES & REGULATIONS OF THE NEPRA ACT REGARDING FATAL ACCIDENTS OCCURRED IN LESCO DURING THE FISCAL YEAR 2023-2024.

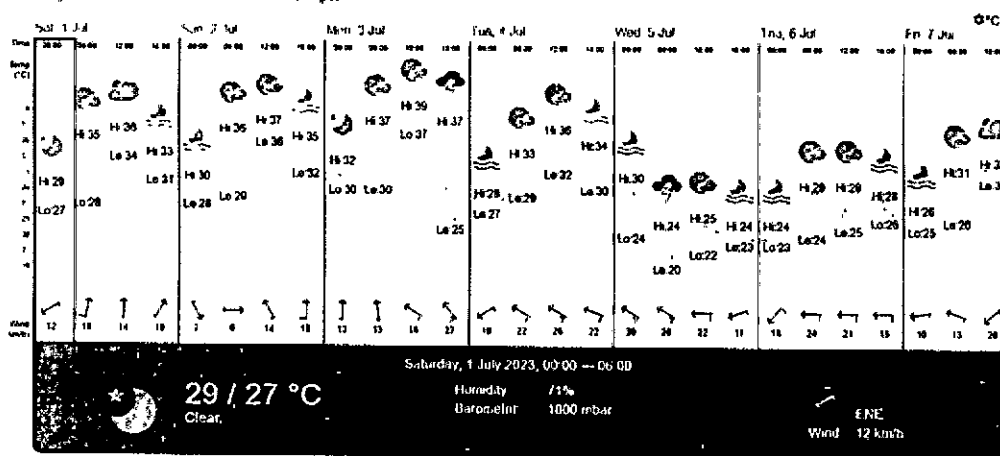
July 2023 Weather In Lahore — Graph

7.10. In the case of the public accident, as LESCO stated that the 11 kV undersized "Gopher" conductor had been in service for a long time. On the day of the incident, LESCO stated that a windstorm caused this conductor to break and fall on the victims. However, only one span of undersized conductor fell; all other 11 kV conductors of appropriate size remained intact. Furthermore, on the date of the accident, July 1, 2023, at 02:57 AM, the recorded wind speed was normal at 12 km/h, whereas abnormal wind speeds are considered to be above 32 km/h. Below is the weather report).
