# National Electric Power Regulatory Authority

NEPRA Alert # 2021-01/ August 4, 2021

### Flashover during Hotspot Rectification, Inspection, and Cleaning Activity

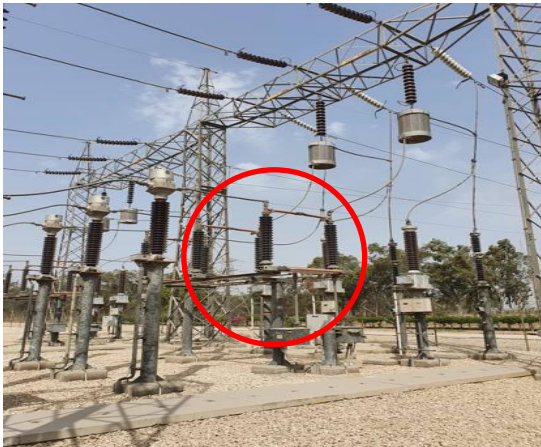
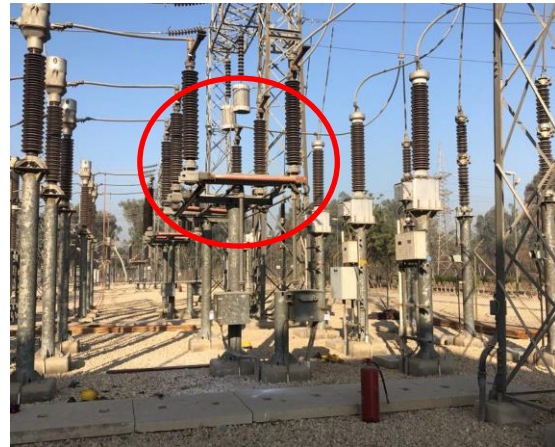
Figure: Incident Location

Two contractor workers were injured due to a flashover on a live/ energized isolator while working to attend hotspot rectification, inspection, and cleaning of the insulators at 132kV switchyard area. Both victims were transferred to the hospital, the first victim was discharged on the same day while the second victim passed away on the third day.

1. Safe work practices and procedures shall be ensured to adequately plan, coordinate, direct, perform, monitor, and enforce work requirements at the site to carry out activities under safe conditions.

2. Work Permit Issuer and Receiver shall both apply their own LOTO for electrical and/or mechanical isolation before issuing of Work Permit. Work Permit Issuer will be the first to apply his lock/tag and will be the last to remove his lock/tag after closure/cancellation of work permit.

3. Work Permit Issuer and Receiver shall adhere to established work permit procedure and safe work practices for closing/canceling of the Work Permit.
4. Switchyard gate key shall be secured by the area owner to control unauthorized entry without isolation and work permit.

5. The area owner shall ensure that all electrical requirements, safe work practices, and procedures are well coordinated between all involved parties to protect workers.
